## Waterloo Integrated Station Development

# Noise and Vibration Annual Monitoring Report

October 2021 to September 2022

DOCUMENT No: SMCSWSWL-JHG-SWL-EM-REP-000015

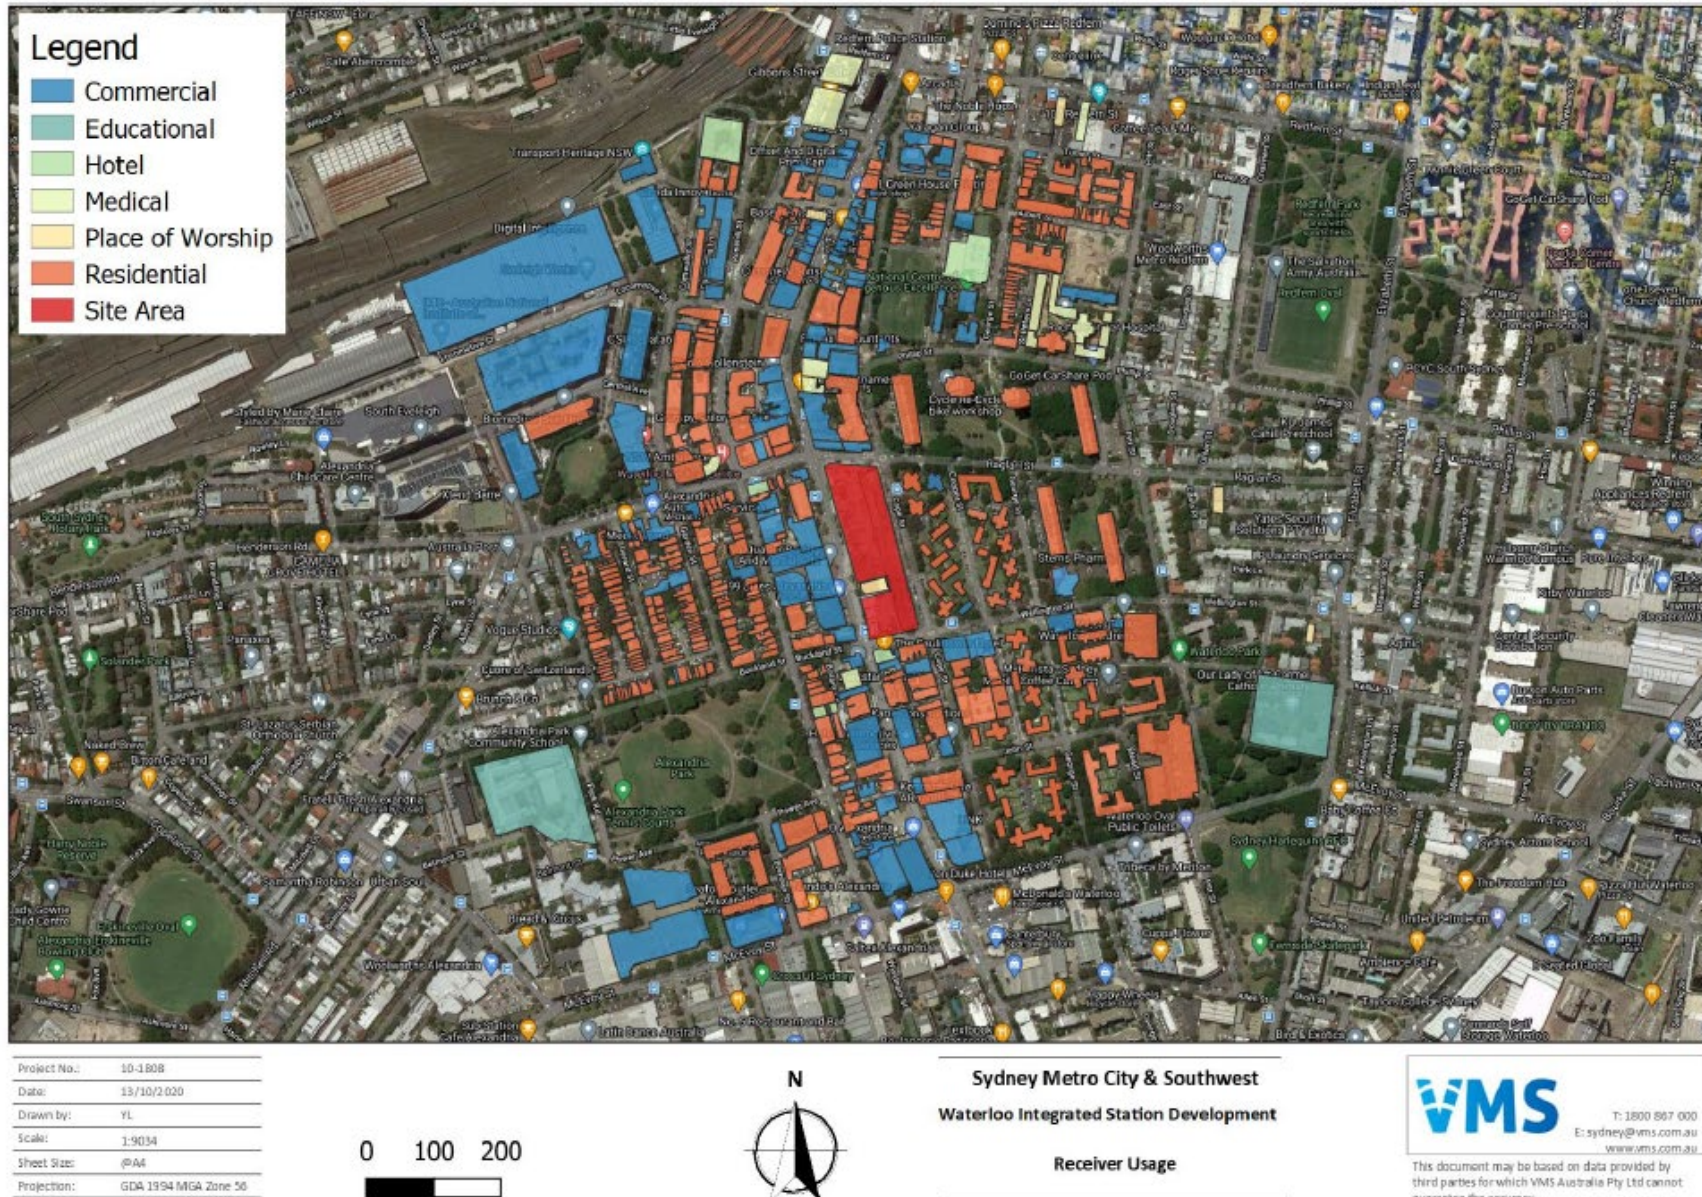
Figure 2 Noise Sensitive Receivers

The Waterloo ISD Construction Noise and Vibration Impact Statement (CNVIS) assessed the sensitive receivers potentially affected by construction noise. The receiver locations representing noise and vibration are shown in Figure 2 and Figure 3 .
