Waterloo Integrated Station Development

Noise and Vibration Annual Monitoring Report

October 2022 to September 2023

DOCUMENT No: SMCSWSWL-JHG-SWL-EM-REP-000016

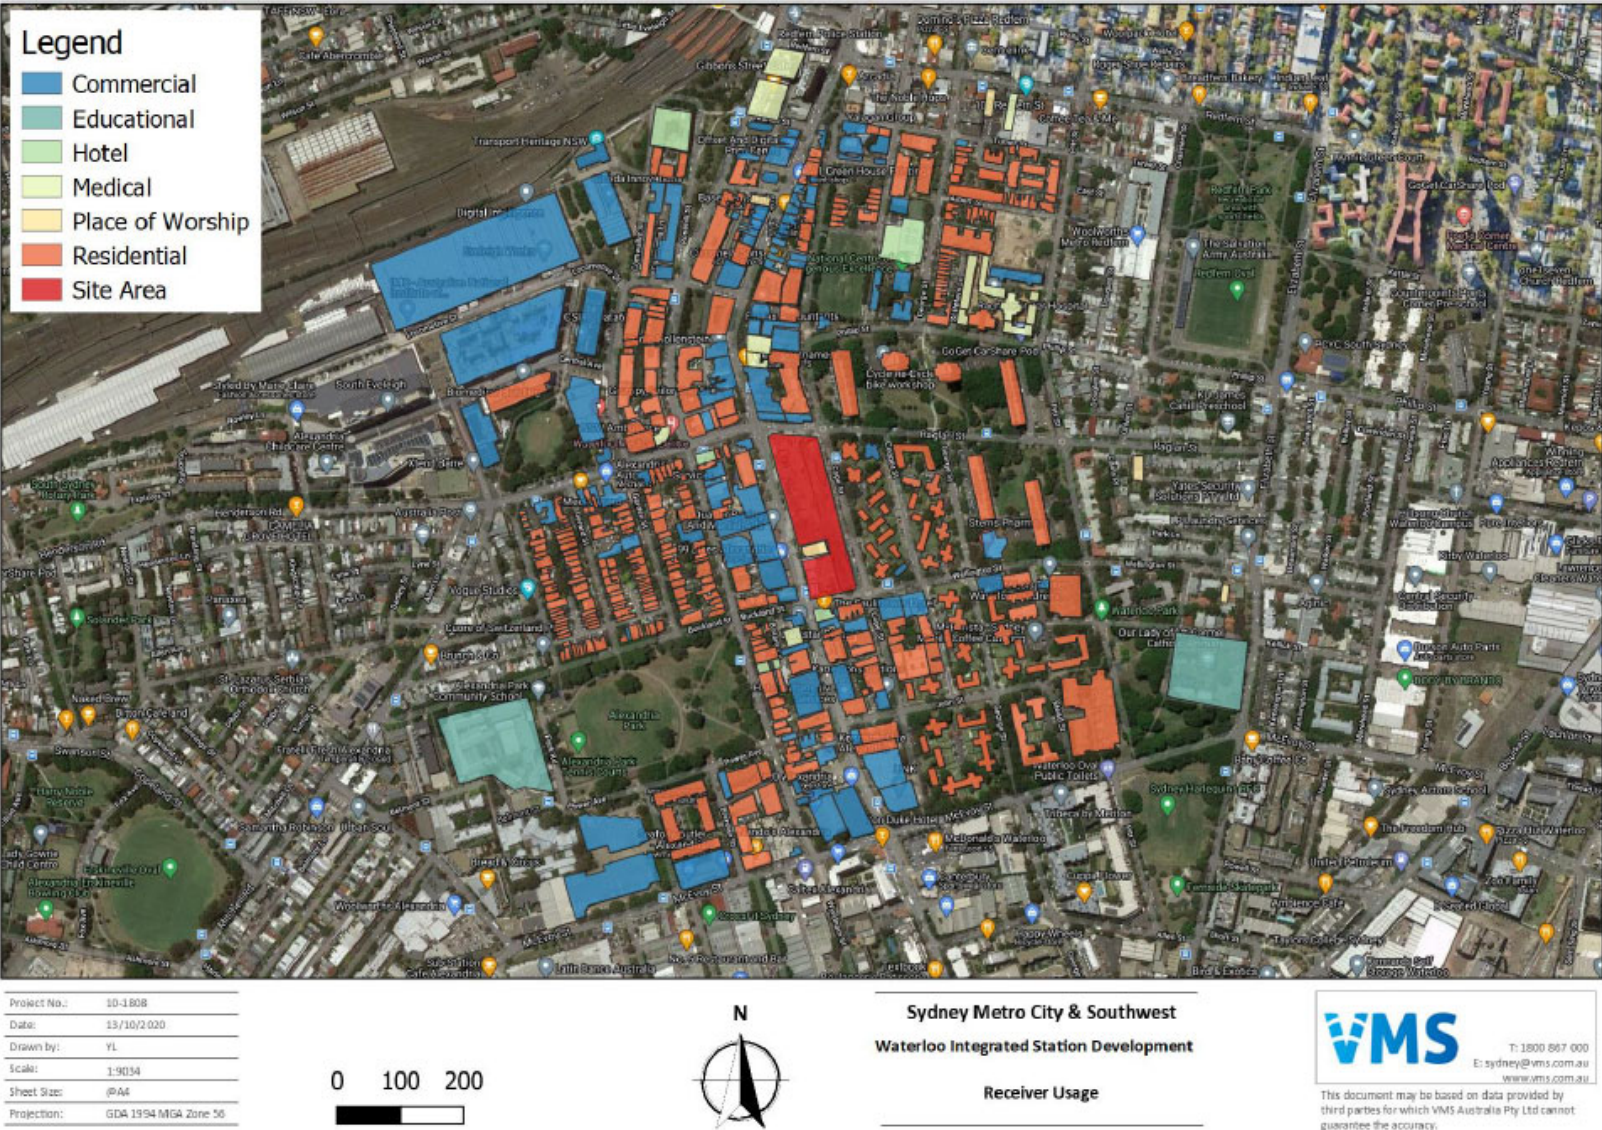
Figure 2 Noise Sensitive Receivers

The Waterloo ISD Construction Noise and Vibration Impact Statement (CNVIS) (Rev 04) assessed the sensitive receivers potentially affected by construction noise. The receiver locations representing noise and vibration are shown in Figure 2 and Figure 3 .

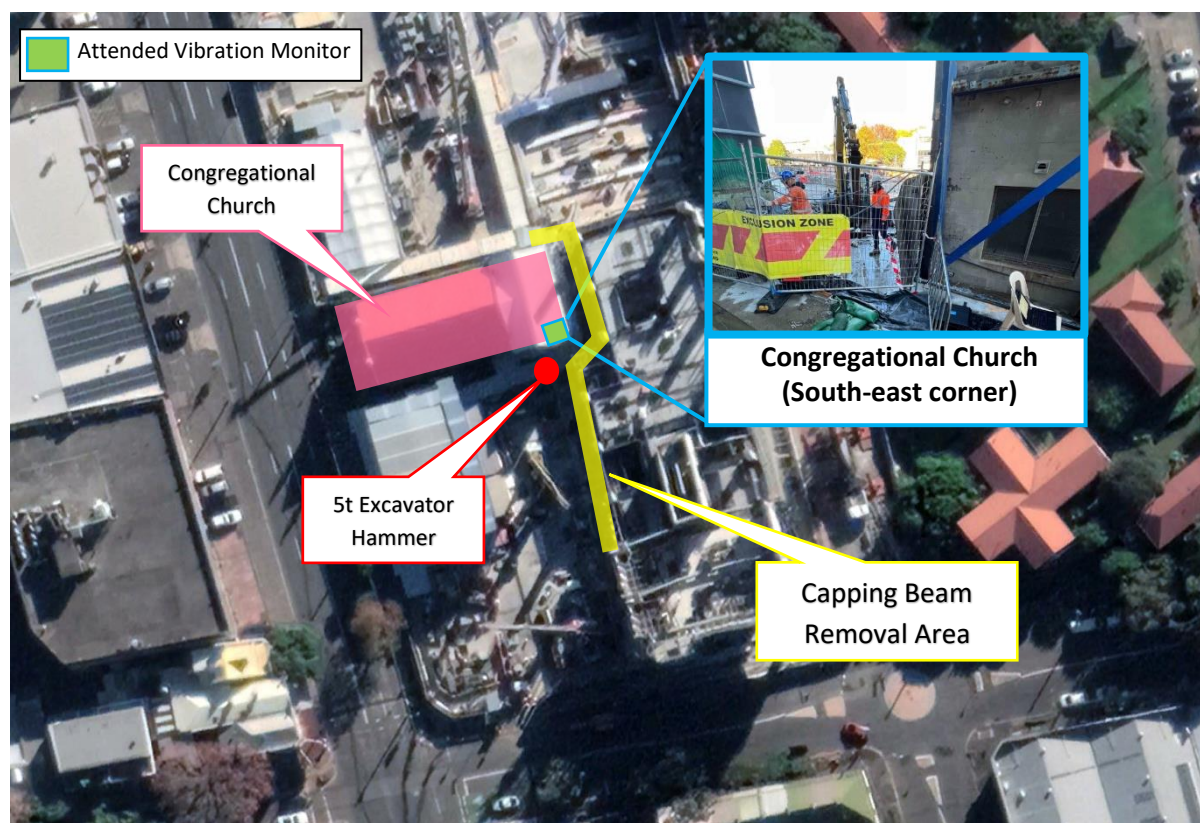
Figure 1 Operator-attended Vibration Monitoring Location

The Project Site layout and operator-attended vibration monitoring location is shown in **Figure 1**.

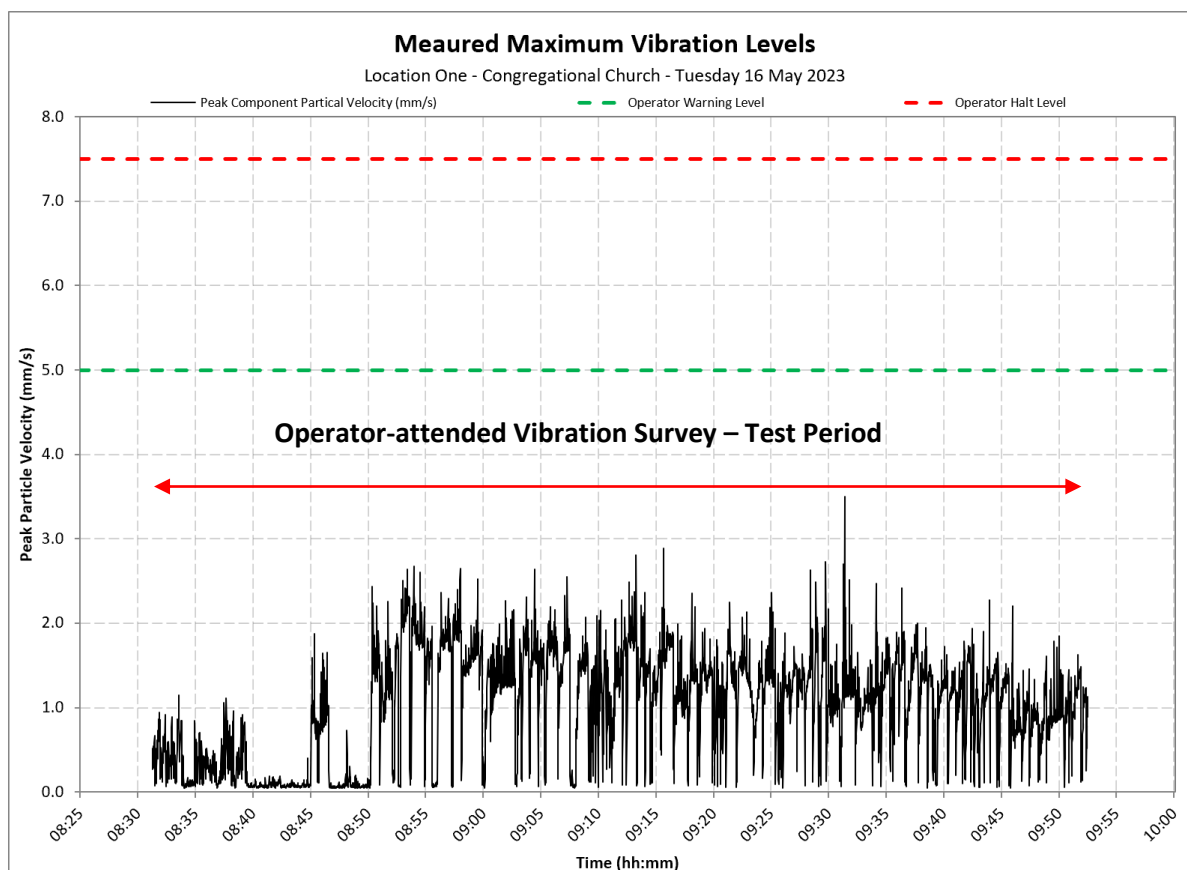
Figure 2 Measured Peak Vibration Levels

Note 1: Refer to **Table 1**. Operator warning level of 5.0mm/s and operator halt level of 7.5 mm/s in accordance with the CNVMP.

The measured vibration levels from the operator-attended vibration survey complied with the nominated project site specific vibration control criteria nominated in **Table 1**.

Operator-attended vibration survey conducted at Waterloo ISD found that the vibration emissions generated by the 5t excavator hammering complied with the relevant structural damage vibration control criteria as nominated in the CNVMP and would not cause structural damage to the existing Congregational Church structure.

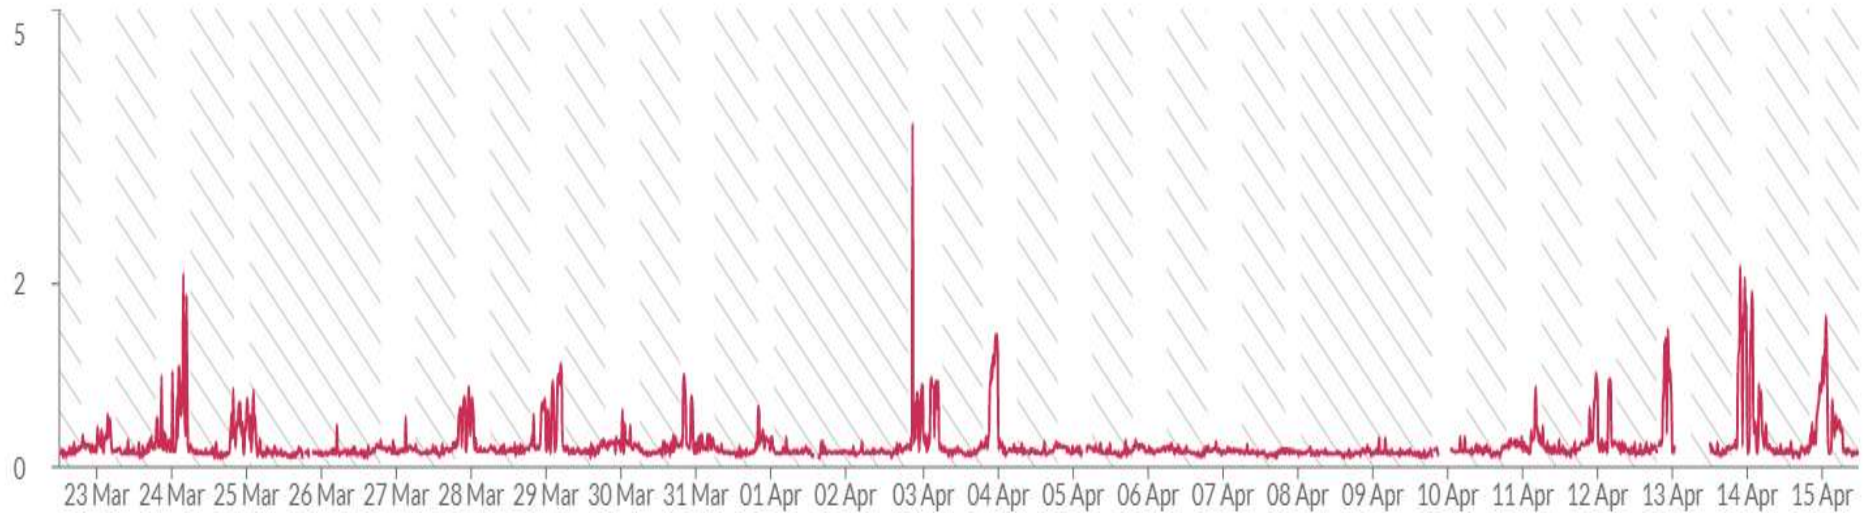
Devices — 7361 - Church

23 Mar 2023 - 15 Apr 2023

mm/s

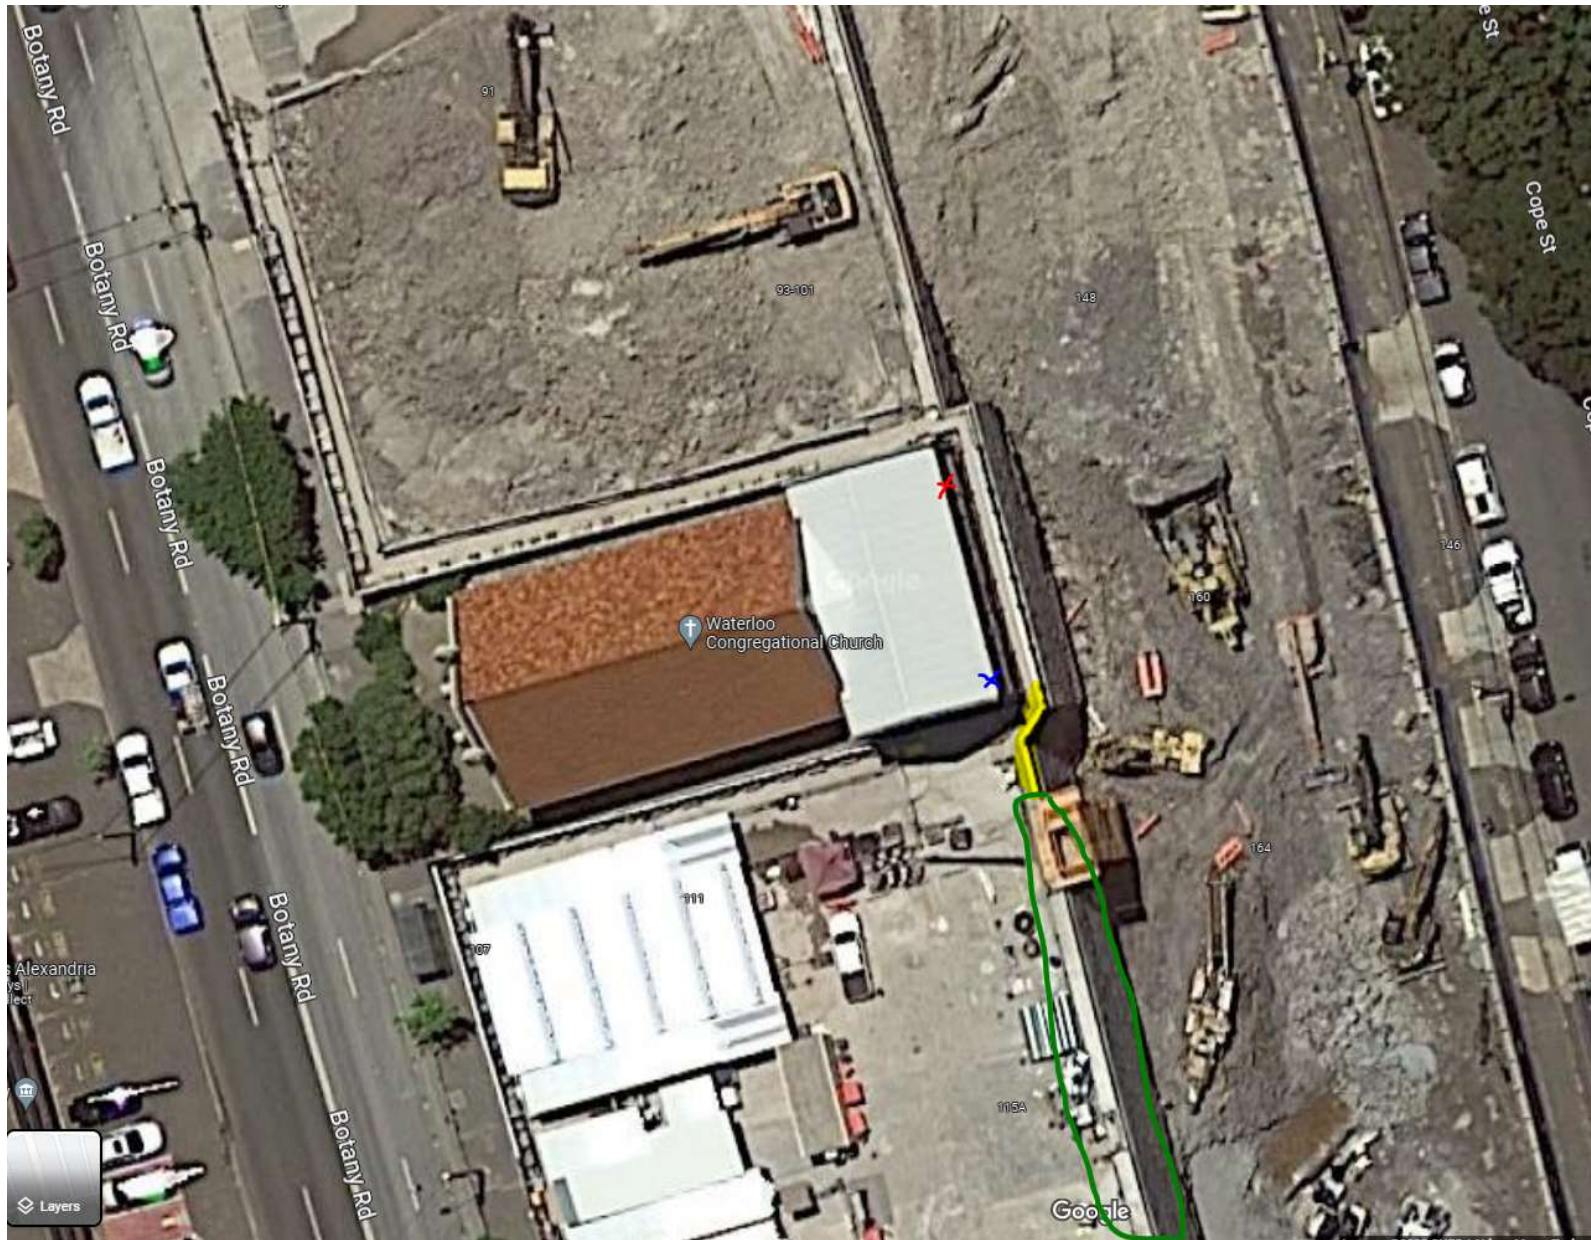
Location of vibration monitor (marked red “x”), location of proposed capping beam demolition with 5T excavator (highlighted), proposed new location of vibration monitor for works (marked blue “x”). Completed capping beam demolition with 14T excavator with hammer.

Please send me your VO proposal for above scope but also include second stage demolition which will start in next 2 months. For the second stage, which is full length demolition behind the Church, we need assessment based on the results obtained during first stage works with instructions to proceed with minimum risk to the heritage object.
